**SUNShINE**  
SAVE YOUR BUILDING  
BY SAVING ENERGY

## Deep renovation of multifamily residential buildings ANALYSIS OF CASE STUDIES

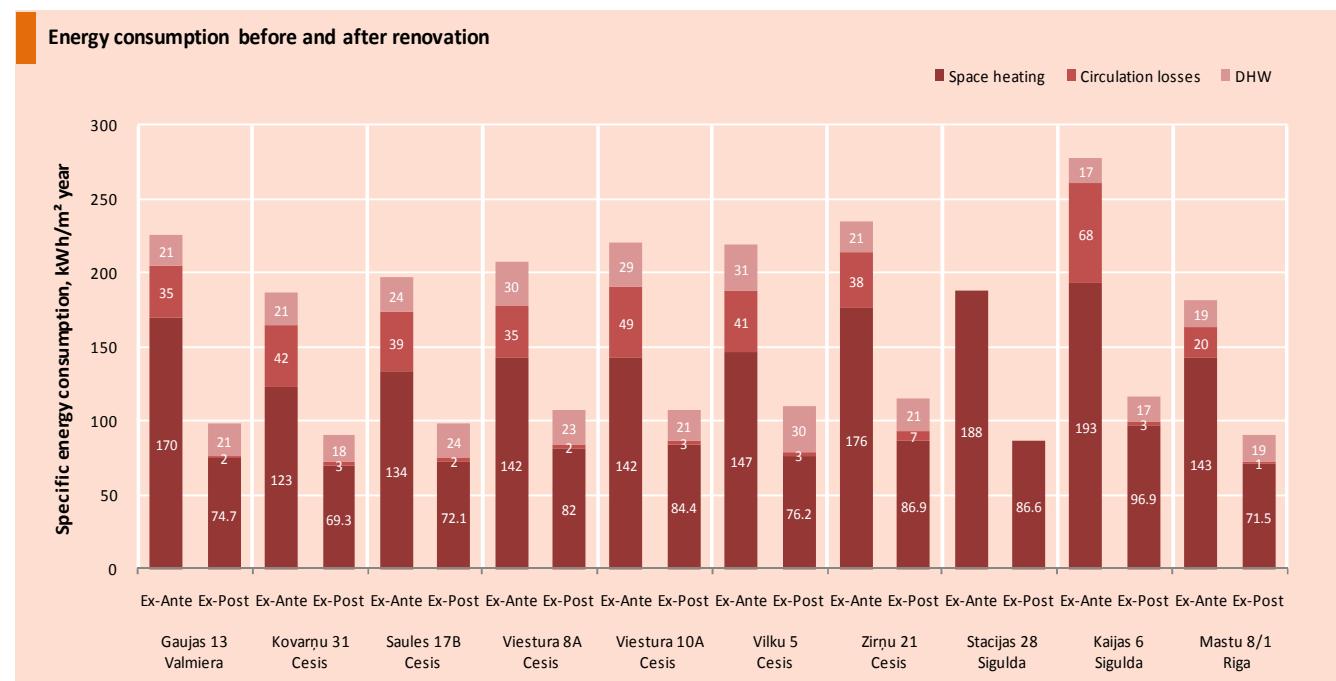
These outstanding results have been achieved thanks to the deep renovation of these buildings. The cost of renovation varied from 90 €/m<sup>2</sup> to 147 €/m<sup>2</sup> (ex-VAT) depending from the year of renovation, building type and the technical conditions before renovation (see chart next page). Of these costs about 9% to 25% were spent for the implementation of important repairs measures on foundation,

roof, balconies, staircases and entrance halls, which are not directly linked to energy savings.

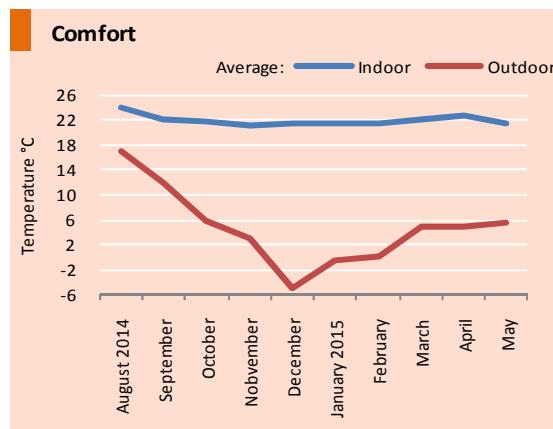
The buildings analyzed in this report are continually monitored. And temperature sensors are installed in several flats measuring indoor air temperature. Data from the last heating seasons showed an indoor temperature slightly above 21.5°C.

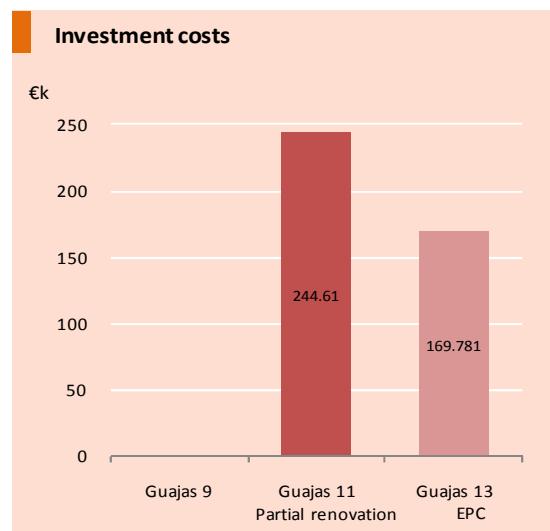
The renovation in Gaujas 11 was about 32% (approx. EUR 55.000) more expensive than the renovation based on energy performance contracting made in Gaujas 13; this although less energy efficiency improvement measures were implemented in Gaujas 11. The building in Gaujas 11 was renovated one year later than Gaujas 13, also meaning that partly a cost increase is justified by inflation in the

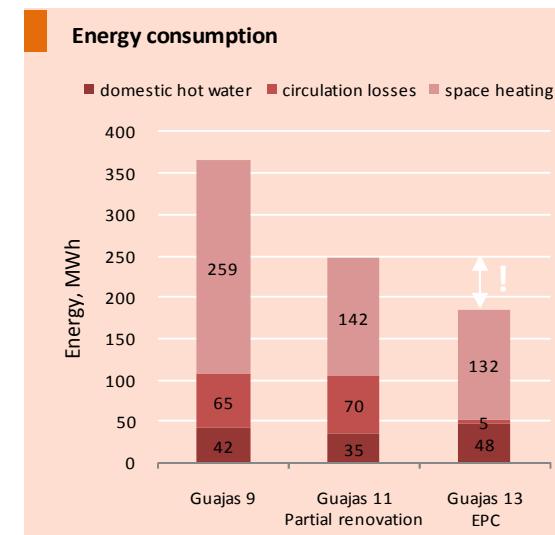
11 Gaujas Street, which was renovated by the home owners, has a total annual energy consumption of 247 MWh (134 kWh/m<sup>2</sup> per year), of which about 35 MWh for domestic hot water preparation and 70 MWh for circulation losses.

13 Gaujas Street, which was renovated by an ESCO via an EPC, has a total annual energy

consumption of 185 MWh (96 kWh/m<sup>2</sup> per year), of which about 48 MWh for domestic hot water preparation and 5 MWh for circulation losses.

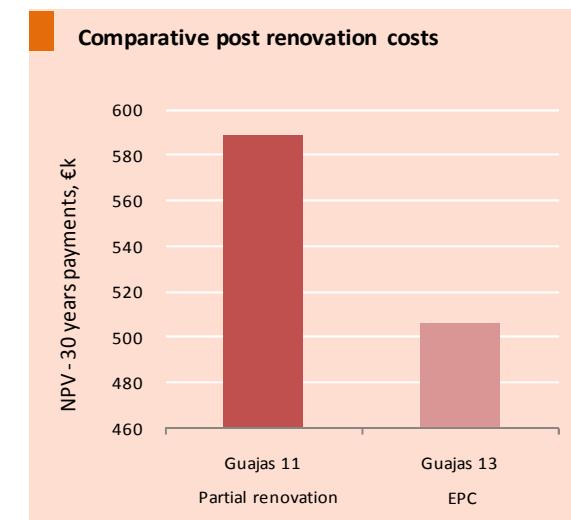
The deep renovation of the building 13 Gaujas Street will extend its life for at least 30 years. Therefore, the residents' payments have to be evaluated in this time period. In particular, the net present value of all future payments is a good indicator for comparing the three buildings under evaluation.

- Inflation 3%
- Discount rate: 6.5%
- 11 Gaujas Street:

- Loan maturity 15 years
- Interest rate: 4.5%+ Euribor
- 13 Gaujas Street:
  - 20 year EPC,
  - Indexed to energy inflation

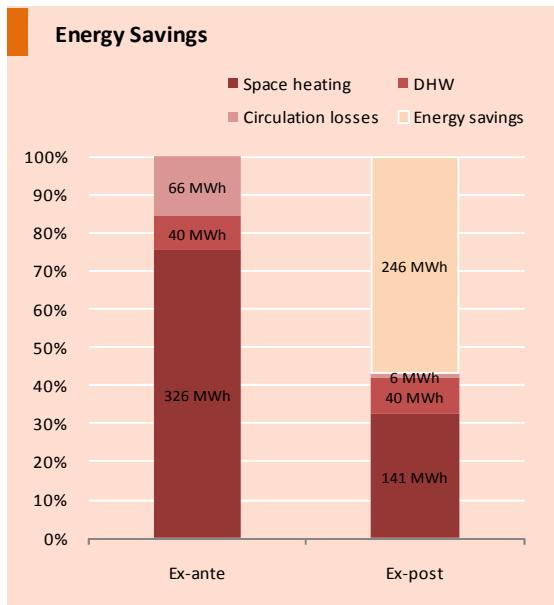
After completion of the construction works, the results are closely monitored. The analysis of the collected data showed energy savings for space heating of 56.7% and a 91.7% reduction of the circulation losses for the domestic hot water system. In total, energy saving summed up to 62.7%, which in absolute terms equals to energy savings of 246 MWh or 64.9 tCO<sub>2</sub> per year. All data are normalized to standard weather conditions.

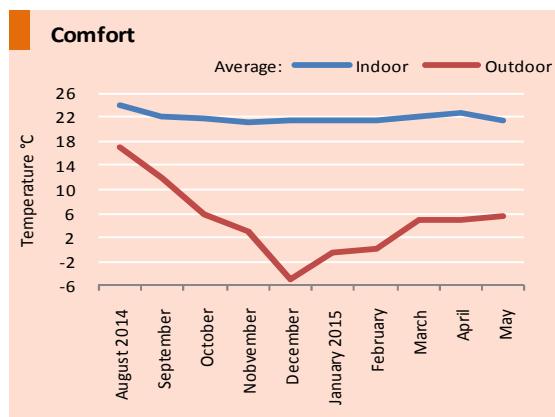
The comfort level is an important aspect of the project and indoor temperature is guaranteed by the ESCO. This is monitored and maintained at around 21.5°C in all heating season.

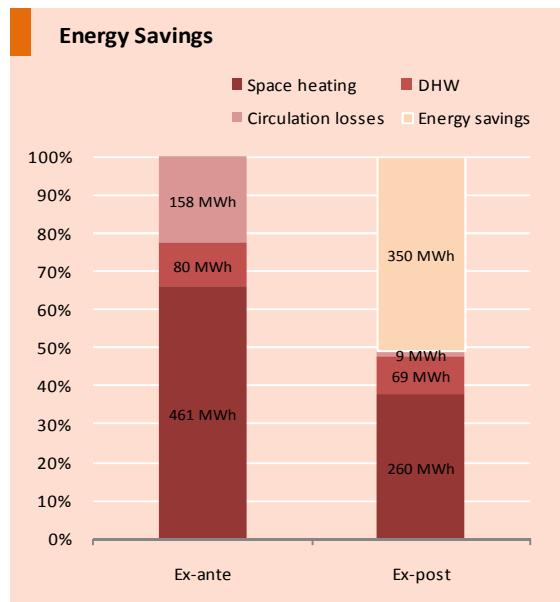
After completion of the construction works, the results are closely monitored. The analysis of the collected data showed energy savings for space heating of 43.6%. Circulation losses for the distribution of domestic hot water have been reduced by 94.3%. The total energy savings are then **56.5%**. In absolute terms this equals to energy savings of 350 MWh or 92.4 tCO<sub>2</sub> per year. All data are normalized to standard weather conditions.

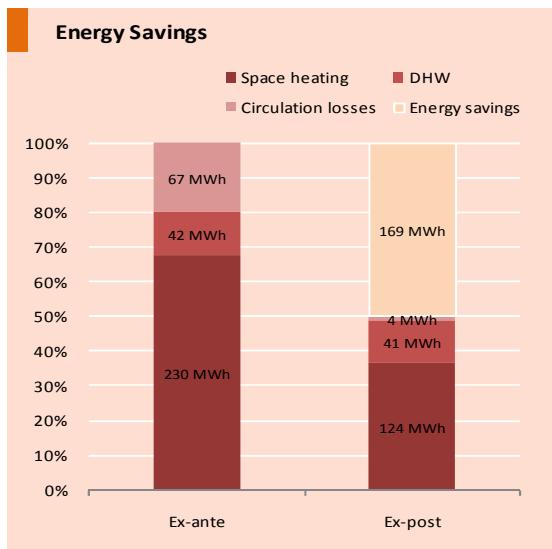
The analysis of the collected data showed energy savings for space heating of 46.1% and a 93.8% reduction of the circulation losses for the domestic hot water system. In total, energy saving summed up to **56.8%**, which in absolute terms equals to energy savings of 169 MWh or 44.6 tCO<sub>2</sub> per year. All data are normalized to standard weather conditions.

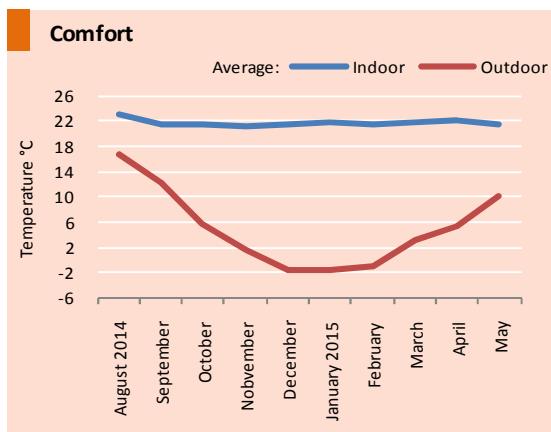
The comfort level is also an important aspect of the project. The indoor air temperature in this project is guaranteed by the Energy Service provider and it is monitored and kept between an agreed range, around 21.5°C.

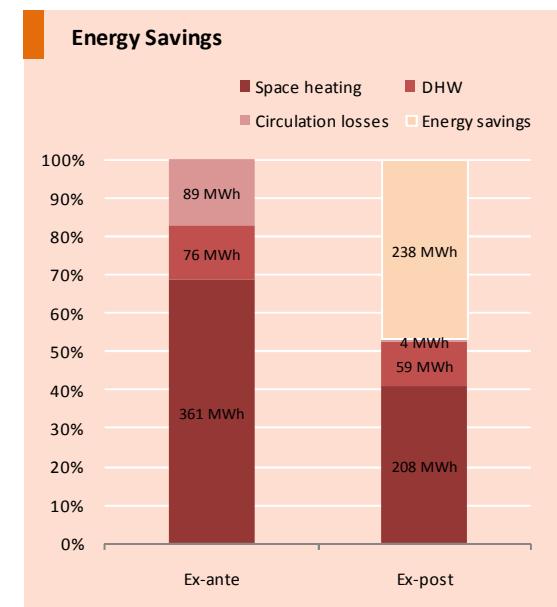
The analysis of the collected data showed energy savings for space heating of 42.4% and a 95% reduction of the circulation losses for the domestic hot water system. In total, energy saving summed up to **52.8%**, which in absolute terms equals to energy savings of 238 MWh or 62.7 tCO<sub>2</sub> per year. All data are normalized to standard weather conditions.
